ADVANCED COMPOSITE ELEVATOR FOR BOEING 727 AIRCRAFT VOLUME 2—FINAL REPORT

Boeing Commercial Airplane Company
P.O. Box 3707, Seattle, WA 98124

CONTRACT NAS1-14952
NOVEMBER 1980

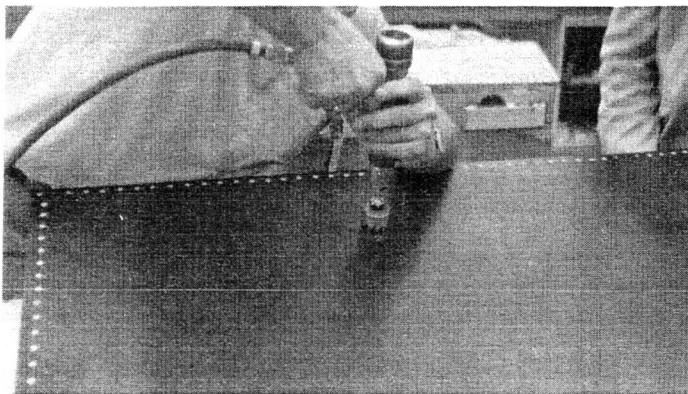
*Figure 171. Sonic Test Box (Test 15) Showing
Start of Repair*

To repair accidental impact damage to the honeycomb skin panel of the sonic test box, the following procedure (illustrated in fig. 170 through 175) was developed and used:

1. Locate damage area.
2. Drill 0.64-cm (0.25-in) pilot hole in center of damaged area. Maximum depth 0.64 cm (0.25 in). Use drill stop.
3. Cut a 5.08-cm (2.0-in) diameter hole through the graphite-epoxy skin, using a carbide-tipped hole saw with a pilot. Use drill stop to prevent pilot from extending deeper than 0.64 cm (0.25 in).

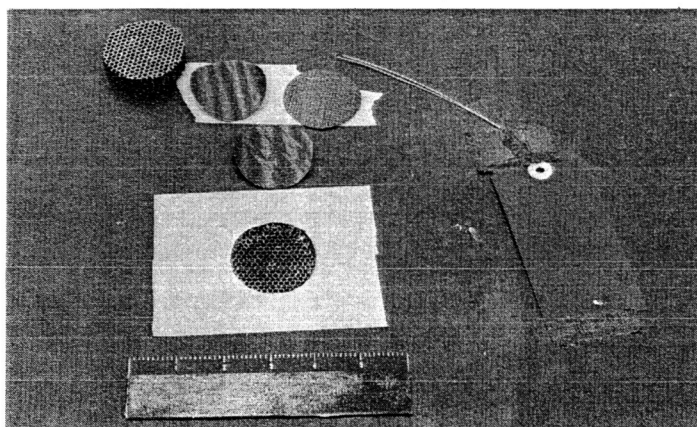
*Figure 172. Sonic Test Box (Test 15) Showing Adhesive,
Precured Graphite-Epoxy, and Core for Repair*

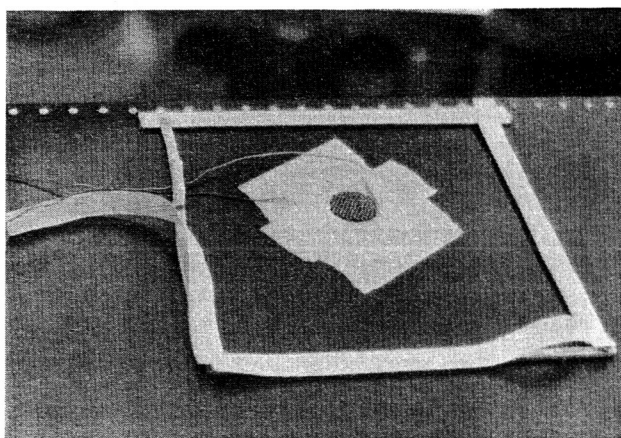
*Figure 173. Sonic Test Box (Test 15)
Showing Core in Place*

9. Cut a Nomex core plug 0.952 cm (0.375 in) thick with a 5.08 cm (2.0 in) diameter.
10. Wrap a layer of foam adhesive around the core plug edge.
11. Insert the core plug into the hole area being repaired.

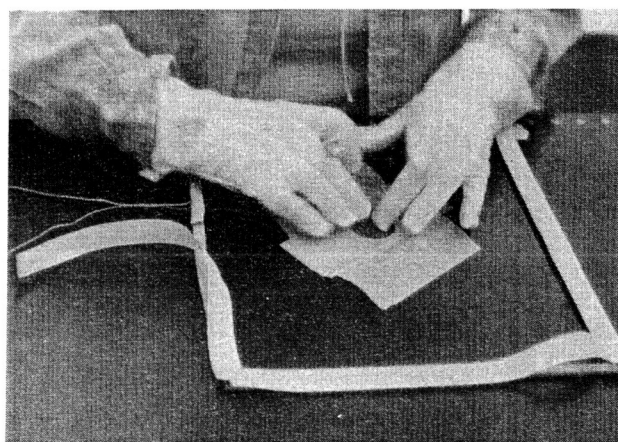
*Figure 174. Sonic Test Box (Test 15)
Showing Precured Graphite-Epoxy
Skins Being Positioned*

15. Apply BMS 5-101 to bond surface of patch.
16. Install patch, centered on repair area, in same ply orientation as graphite-epoxy skin. Mask around patch periphery to control adhesive flash.

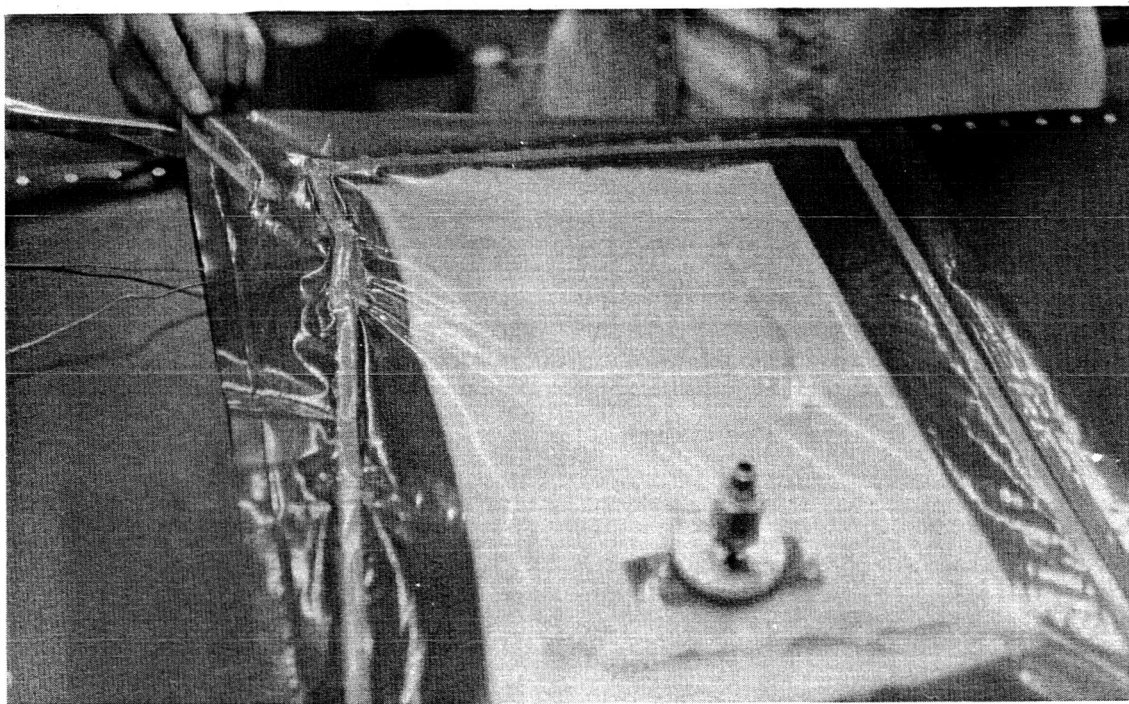
Figure 175. Sonic Test Box (Test 15) Showing Repair Ready for Cure

17. Bag and cure under vacuum (use heating blanket).
18. Remove masking.

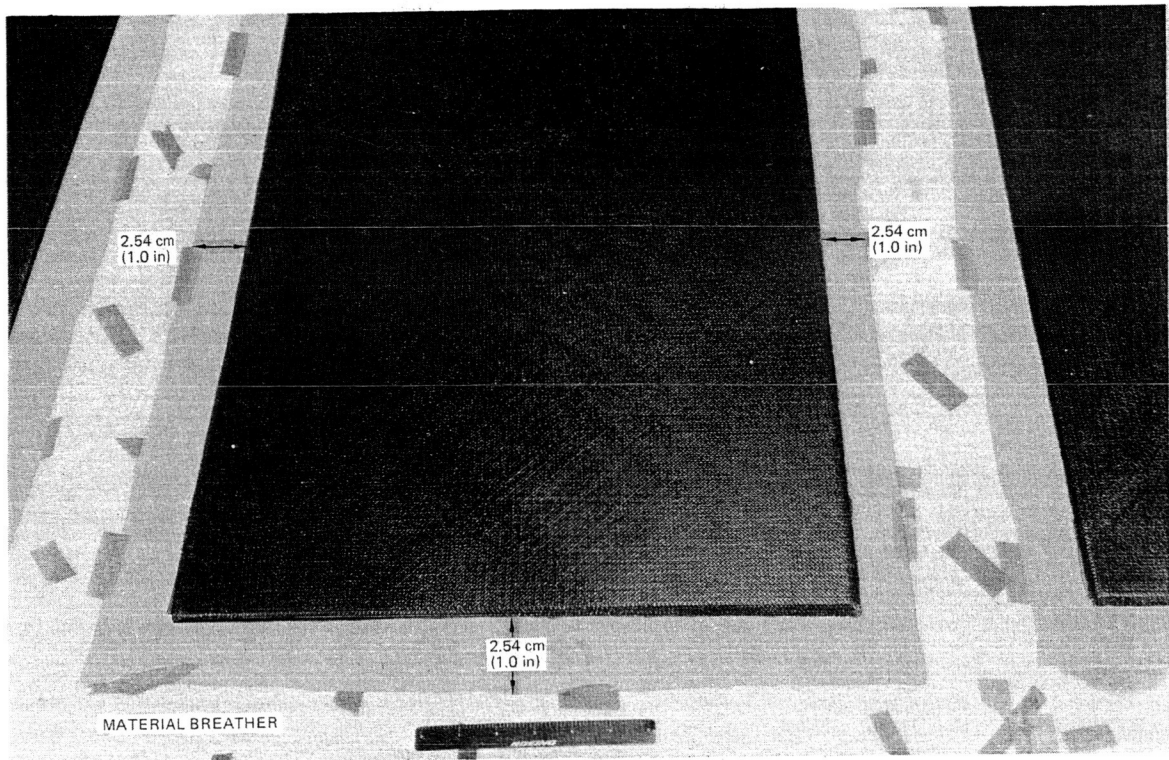
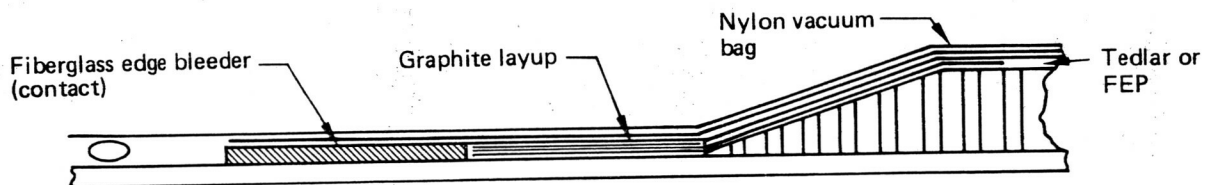
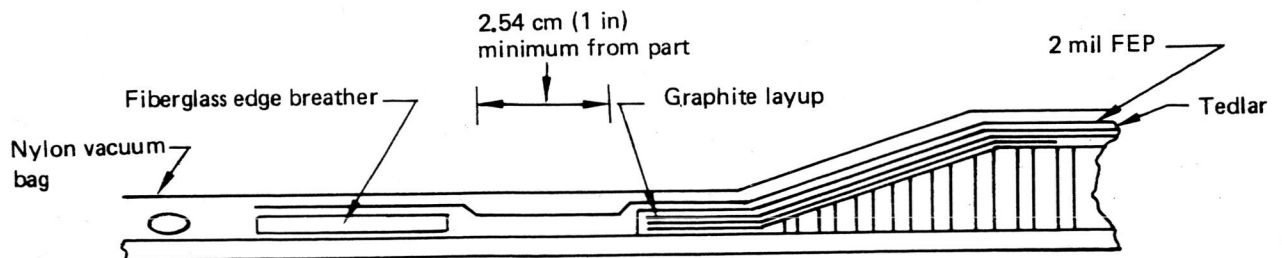
Figure 176. Improved Flow Characteristics of Narmco 5208 Resin

The photograph shows the breather material placed 2.54 cm (1.0 in) away from the panel to reduce or eliminate resin bleedout.

- Parts were cured using the step cure cycle with a bleeder system as shown below.

- The cure was changed to pressure applied at the start of the cure cycle and breather (not bleeder) applied as shown below.

- The bagging eliminated excessive resin bleed.

To resolve this typical problem, bagging techniques were changed to limit contact between the part and the edge breather material and the cure cycle was modified to apply pressure at the start of the cycle. These changes minimized bleed-out and ended rejection for high fiber volume fraction (fig. 176).

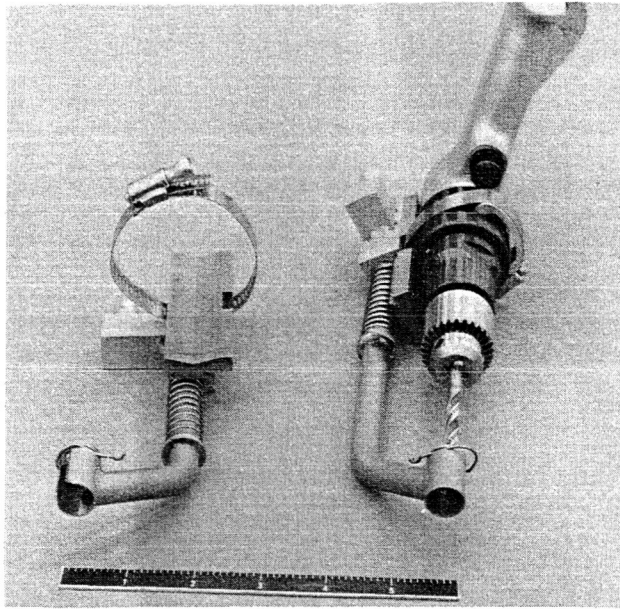
Note:
Vacuum unit can be used with tooling
designed to provide a positive guide.

*Figure 177. Hand Drill (Right), Showing
Standard Vacuum Unit and Modified
Vacuum Unit (Left)*

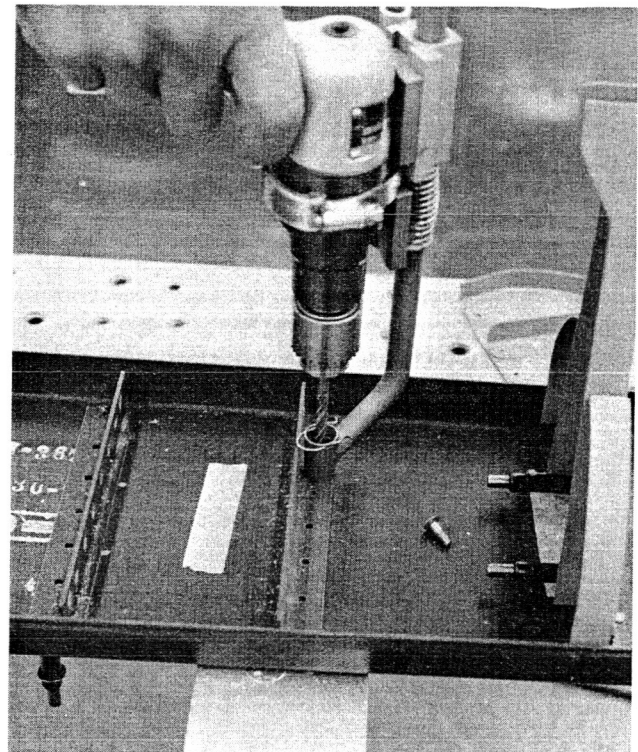
*Figure 178. Drilling Attach Angles on Front
Spar, Showing Interference Between Angle
and Vacuum Collar*

Conventional tooling methods were used to design and construct all tools, but unique features were included to accommodate the special equipment developed for drilling and trimming composite parts. This equipment included such items as high-speed (18,000 rpm) tapered drills, diamond-coated router bits, and dust collection systems. For the latter, vacuum nozzles adapted to drill motors and router units were used in conjunction with portable vacuum canisters, as shown in Figures 178, 180, 181, and 237.

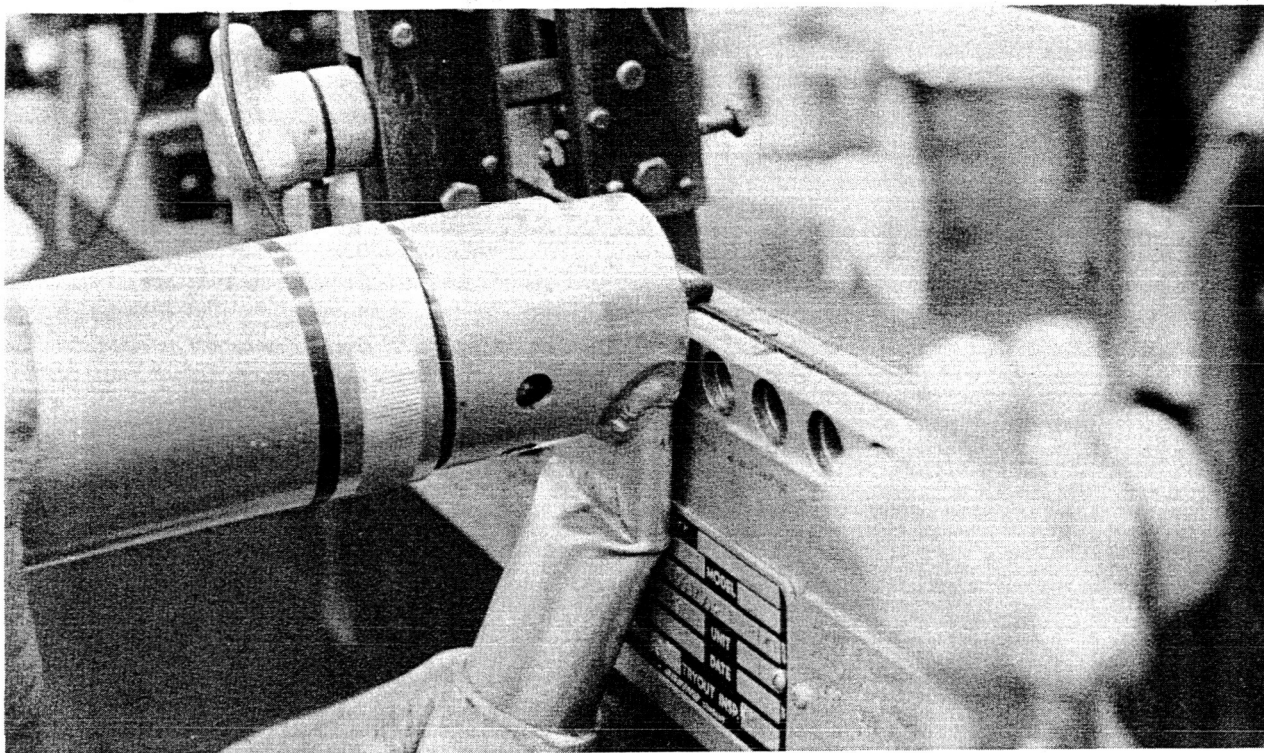
Figure 179. Vacuum Dust Collector Mounted on Standard Router

- Although respirable particles of dust generated during machining of advanced composite materials are not classified as carcinogenic, they are considered to be inert nuisance dusts. OSHA recommends a maximum operator exposure of 10 mg of inert dust per m^3 of air space. Appropriate dust-collection systems are being used in the designated graphite-epoxy machining areas (figs. 179 and 180). A particle count verified collection system performance with escaping particles measuring less than 5% of the allowed maximum of 10 mg/m^3 (0.0004 lb/in^3) of air.

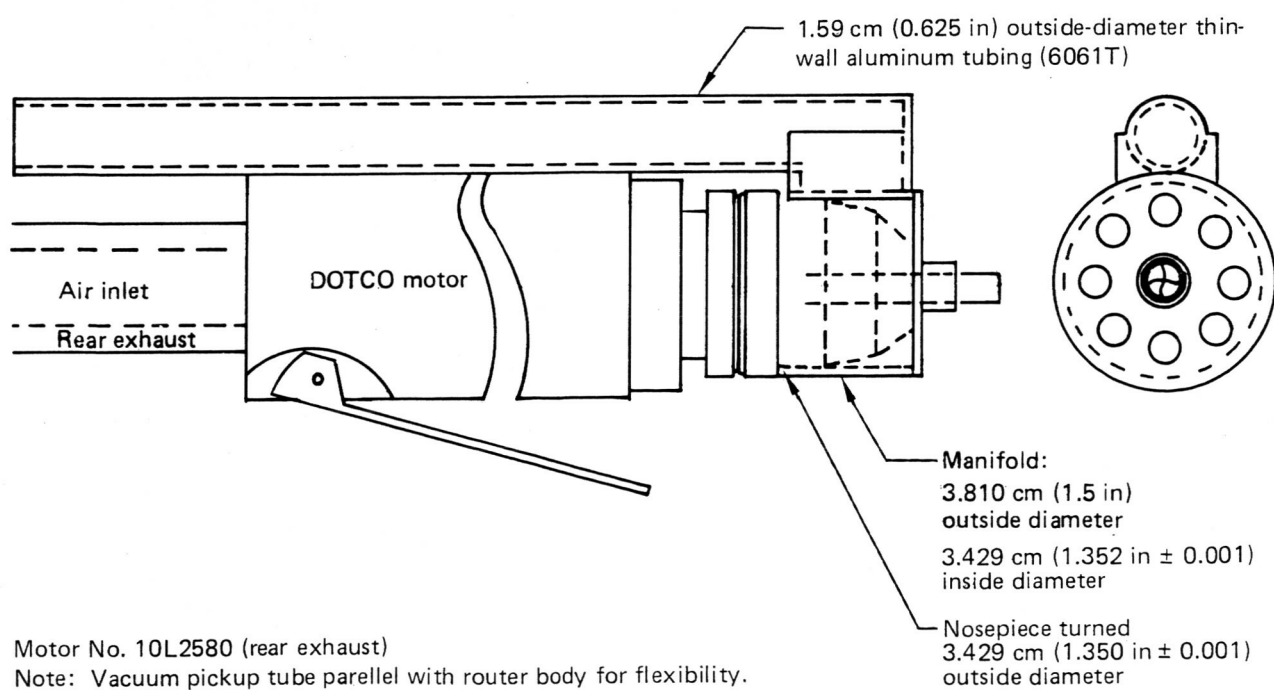
Figure 180. DOTCO Router Motor

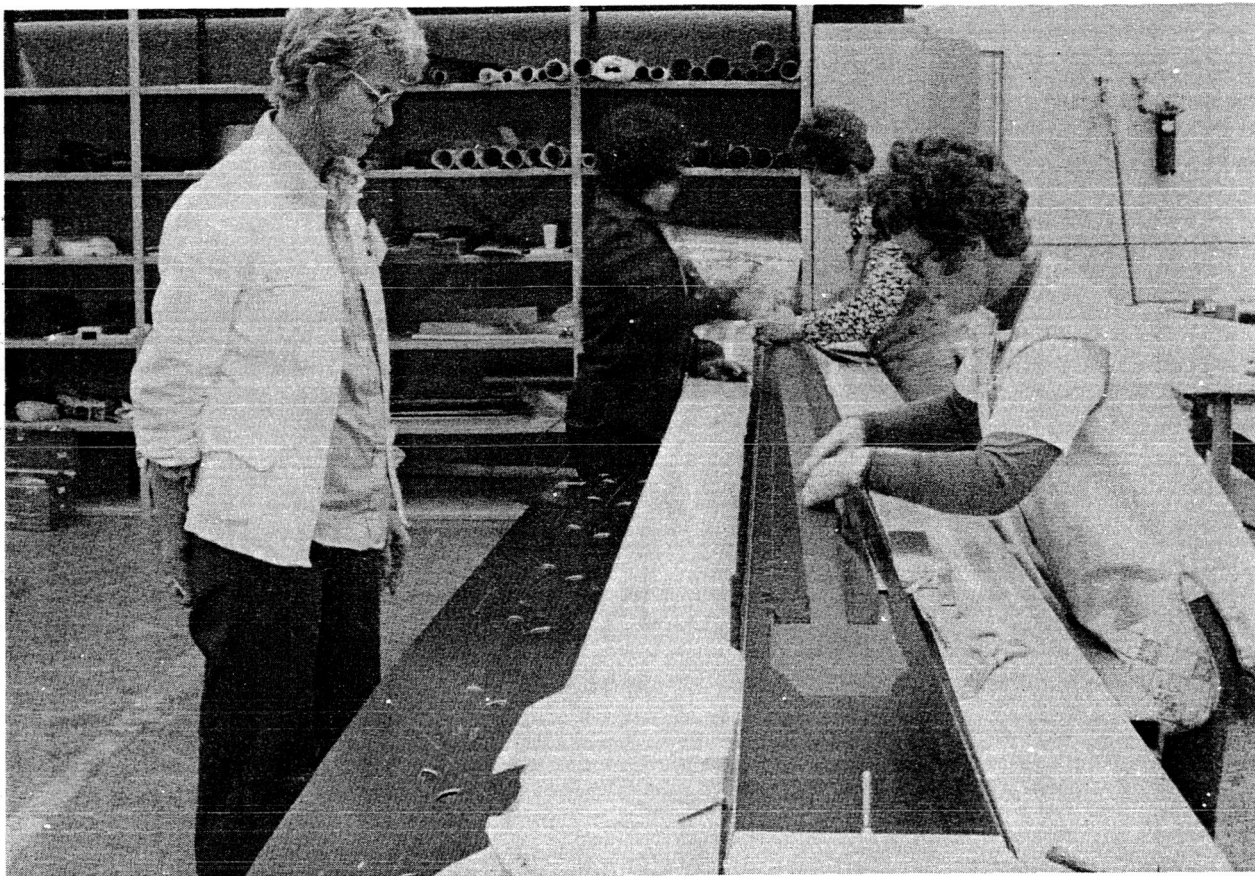
Figure 181. Manufacturing Verification Hardware (Test No. 16) Showing Front Spar Being Laid Up

A full-scale, 203-cm (80-in) long section of the elevator was fabricated to test production detail tools and ensure that no major assembly problems would be encountered during production of the five and a half shipsets. Significant steps in this process are shown in Figures 181 through 188. Three significant facts developed from the fabrication of the verification hardware:

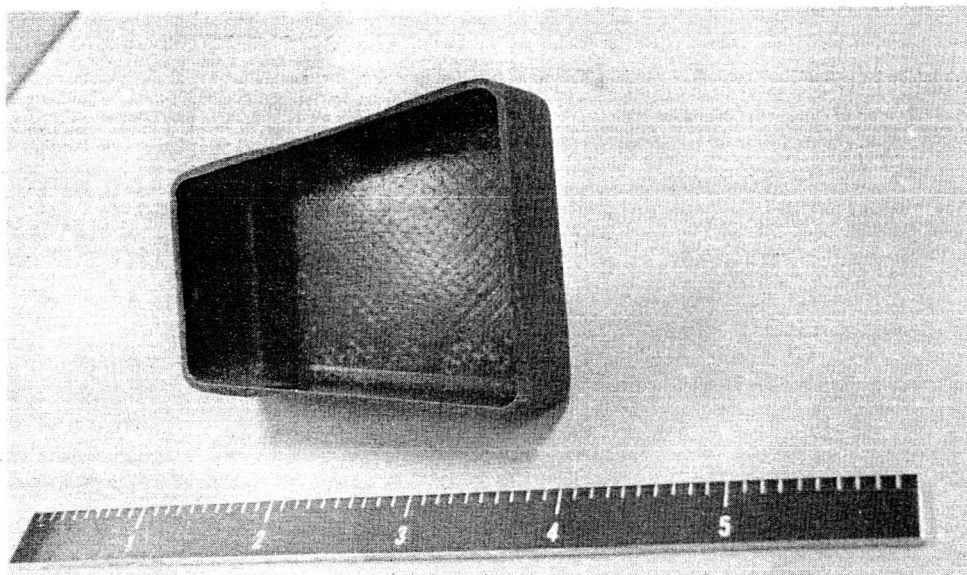
Figure 182. Manufacturing Verification Hardware (Test No. 16) Showing Completed Rear-Spar Header

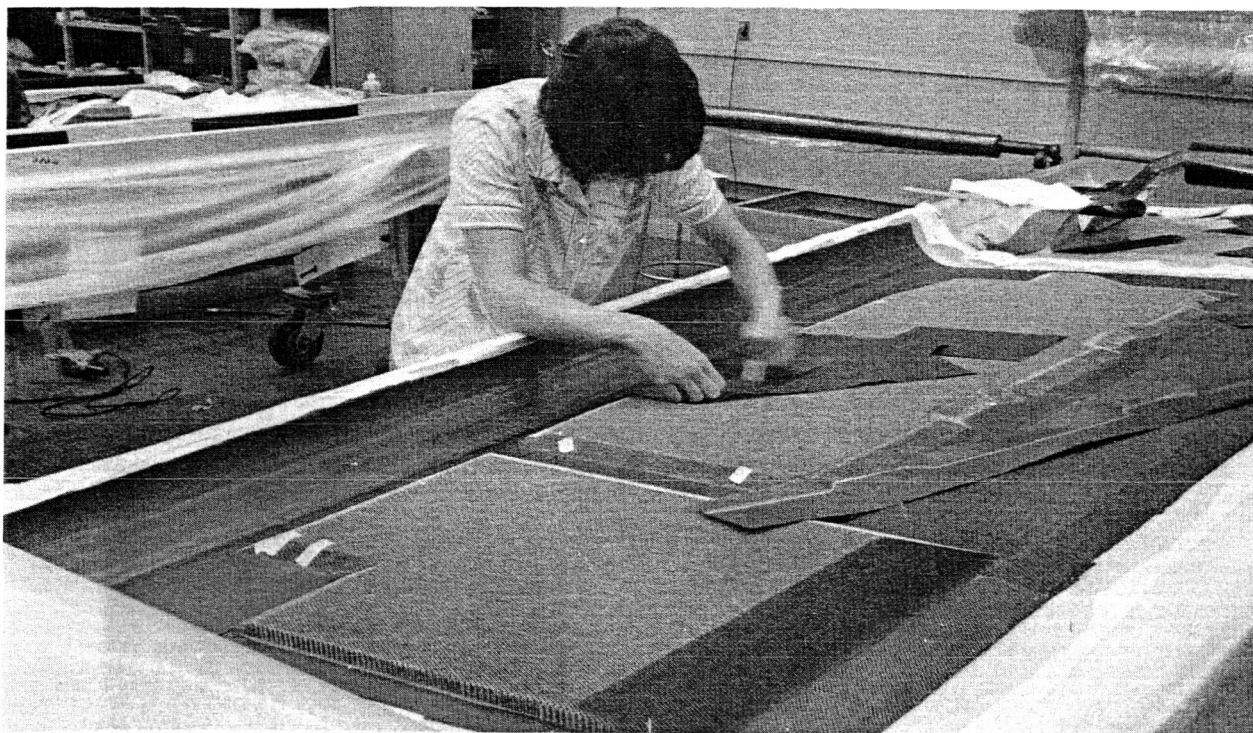
Figure 183. Manufacturing Verification Hardware (Test No. 16 Skin Panel) Showing Doubler Being Laid Up

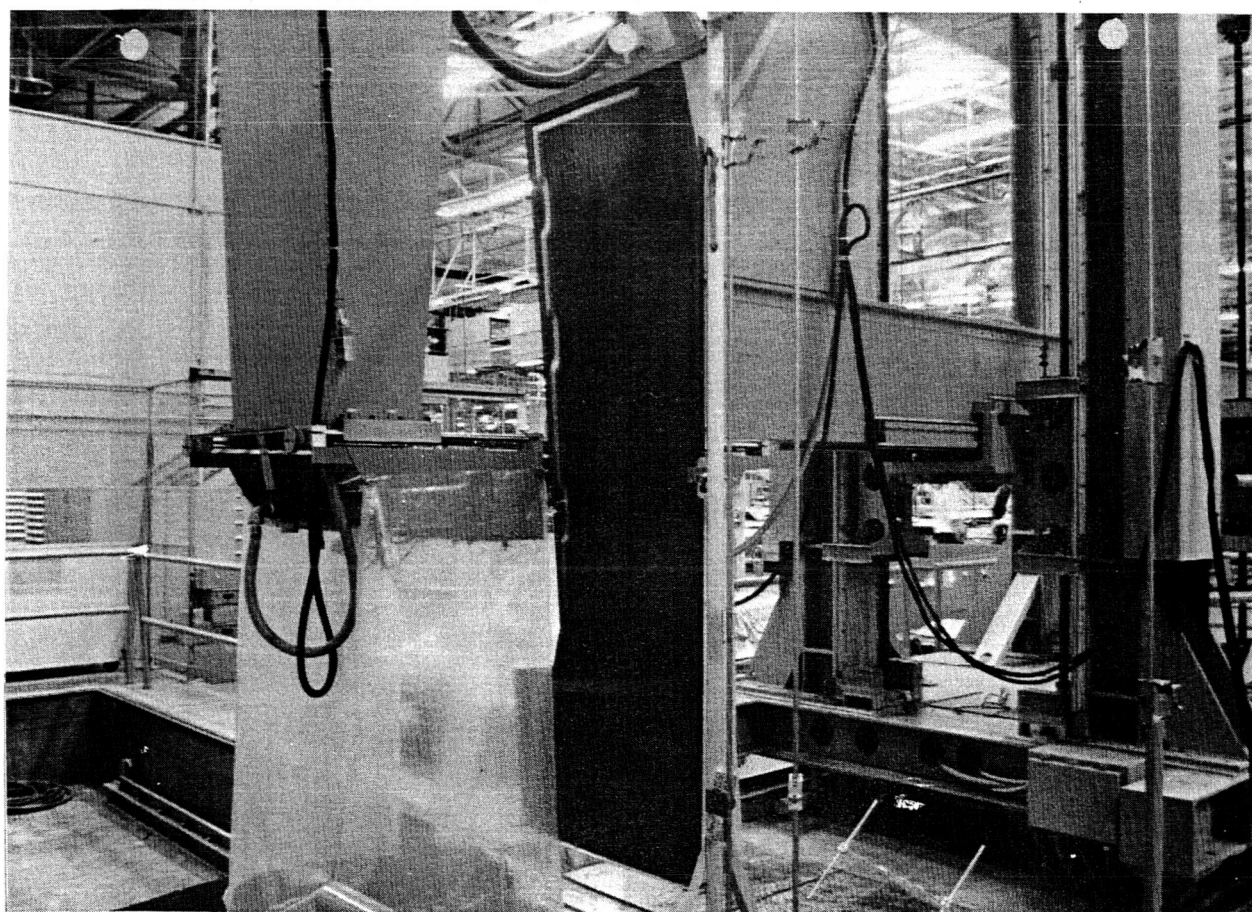
Figure 184. Manufacturing Verification Hardware (Test No. 16) Showing Skin Panel in TTU Inspection

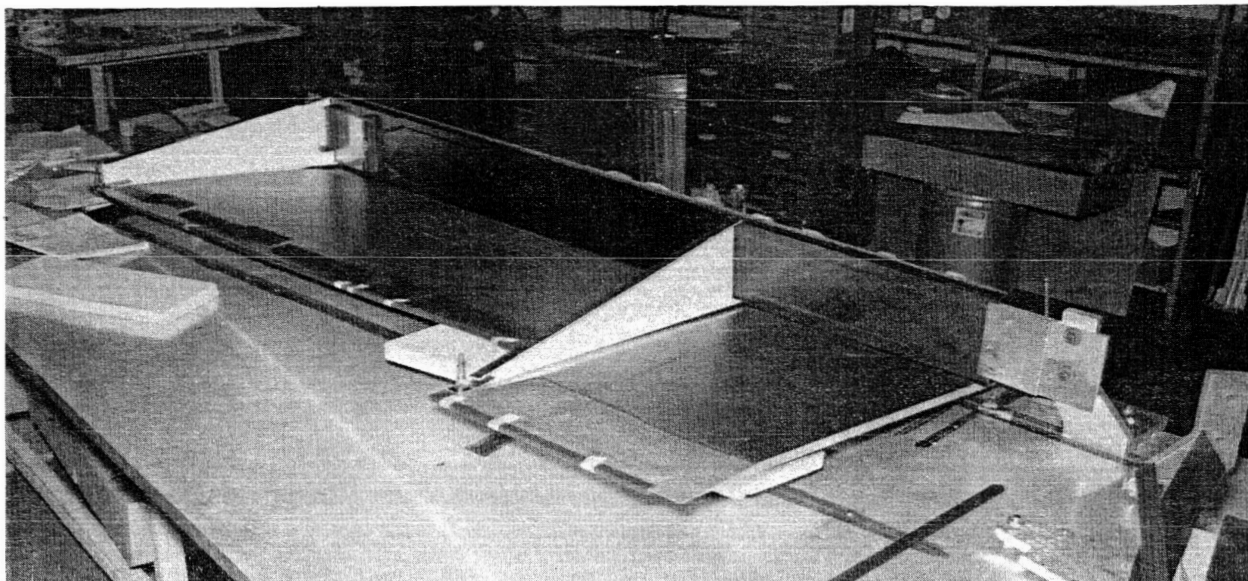
Figure 185. Manufacturing Verification Hardware (Test No. 16) Showing Front Spar, Two Ribs, and Lower Skin Being Assembled

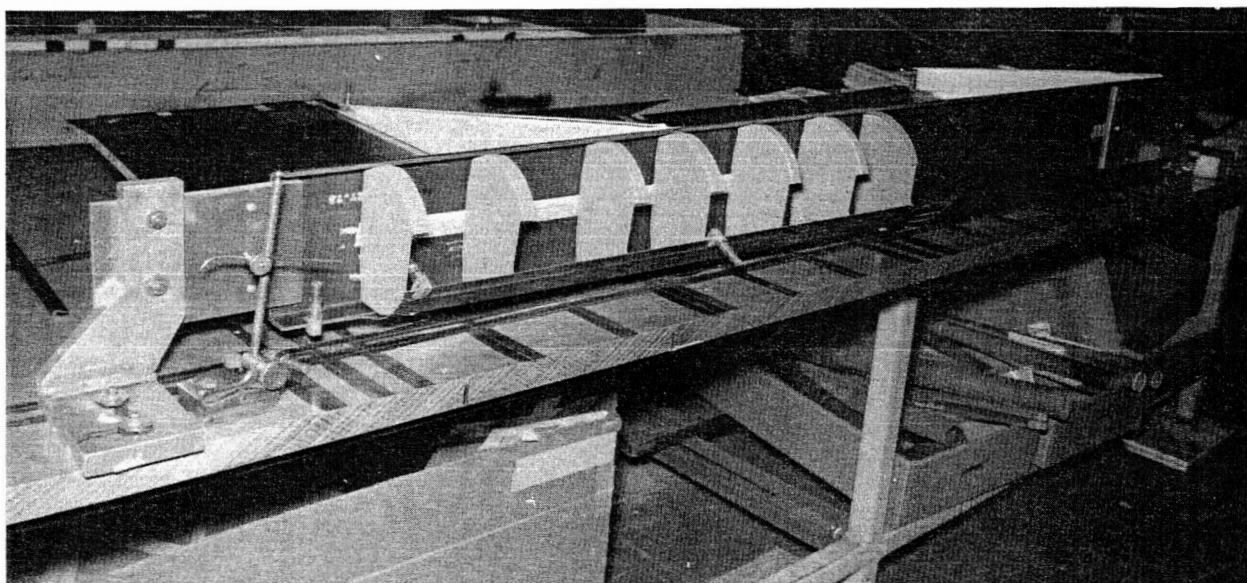
Figure 186. Manufacturing Verification Hardware (Test No. 16) Showing Aluminum Nose Ribs Being Attached to Front Spar

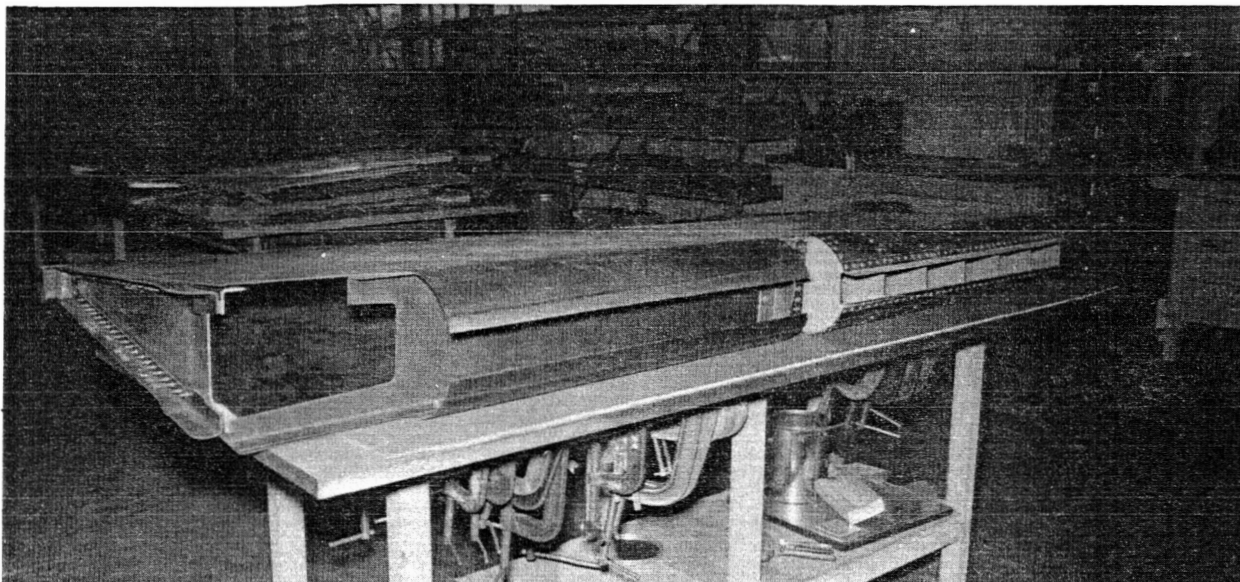
Figure 187. Manufacturing Verification Hardware (Test No. 16) Showing View of Completed Assembly

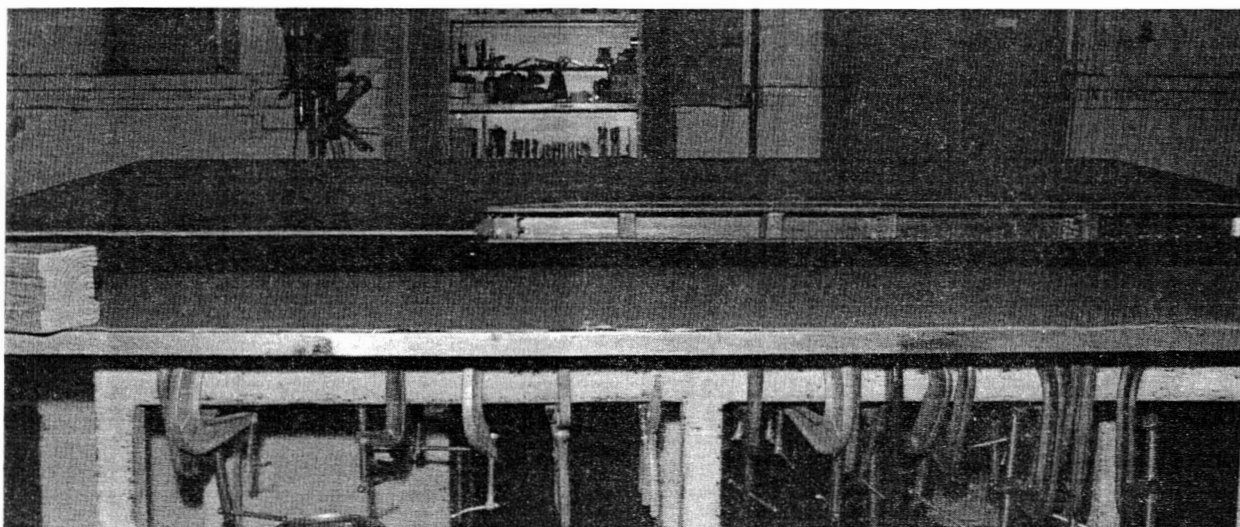
Figure 188. Manufacturing Verification Hardware (Test No. 16) Showing Rear View of Completed Assembly

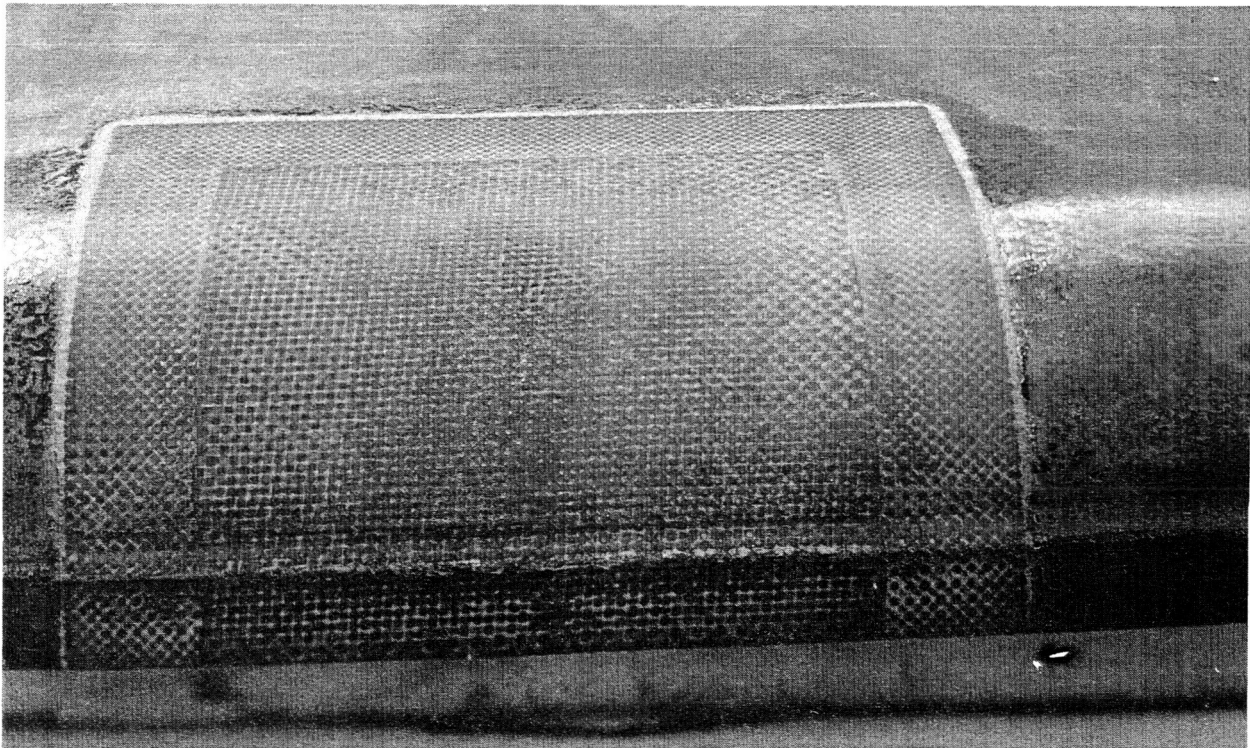
Figure 189. Visually Acceptable Repair to Skin Panel

Figure 189 shows an acceptable repair to a 727 graphite composite elevator skin panel. Figure 190 shows the Fokker Bond Tester being used to inspect bonding characteristics of a repair on the lower skin panel surface of a 727 graphite composite elevator. Figure 191 shows X-rays of two repairs to skin panels on a 727 graphite composite elevator.

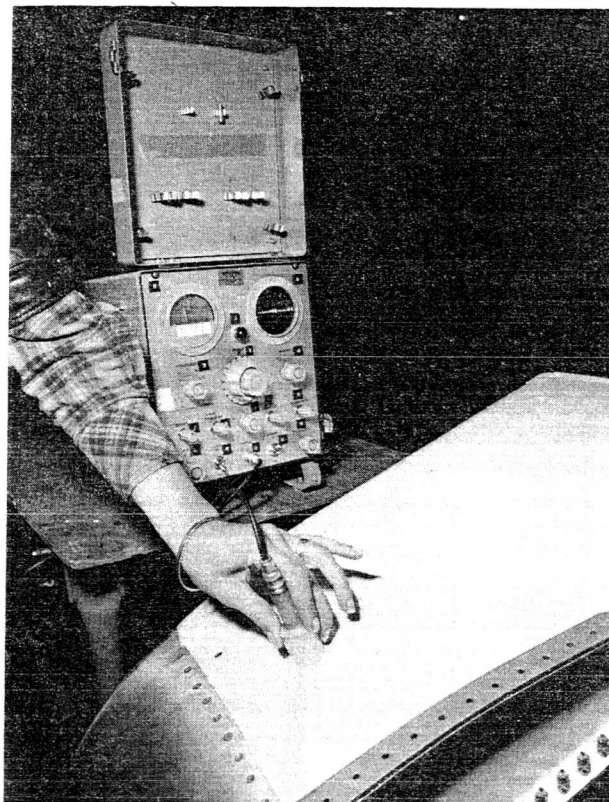
Figure 190. Fokker Bond Tester Inspection of Repair to Skin Panel

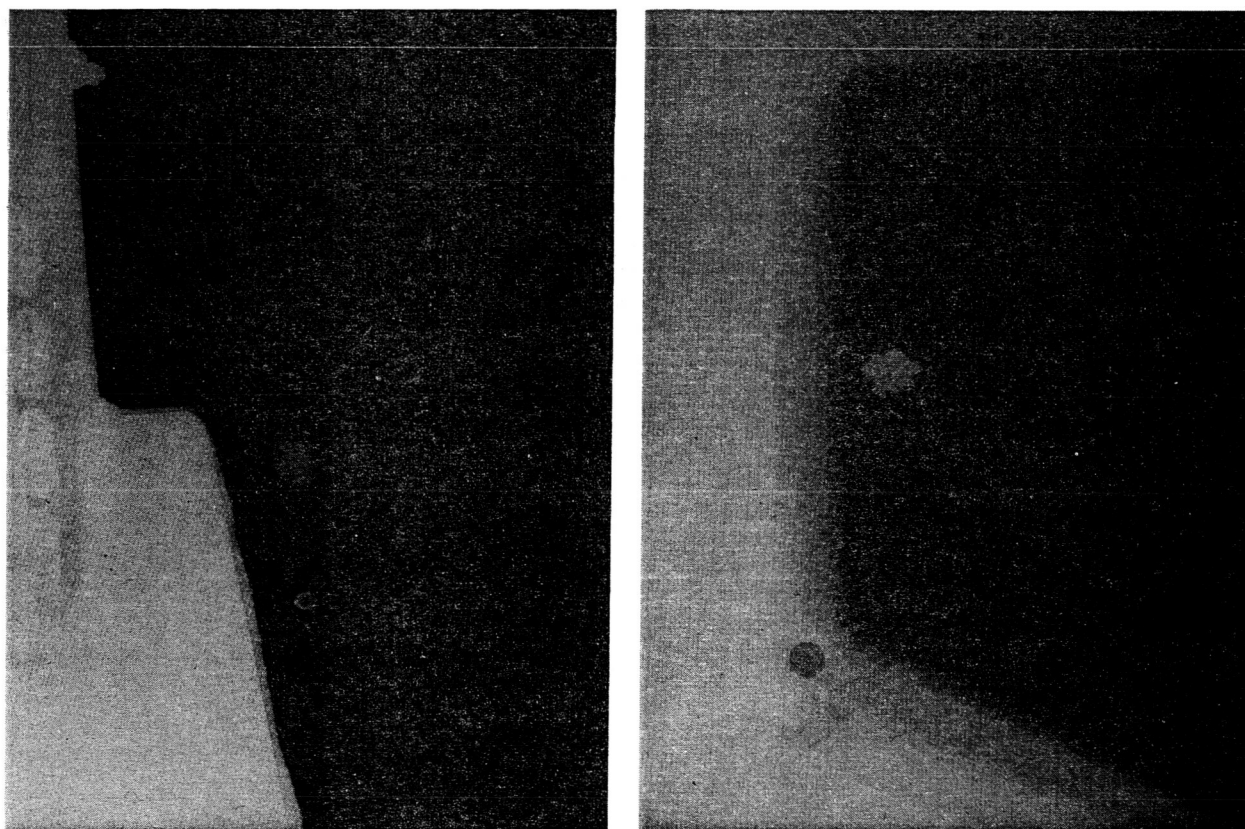
Figure 191. Examples of X-ray Examination of Repairs to Skin Panels

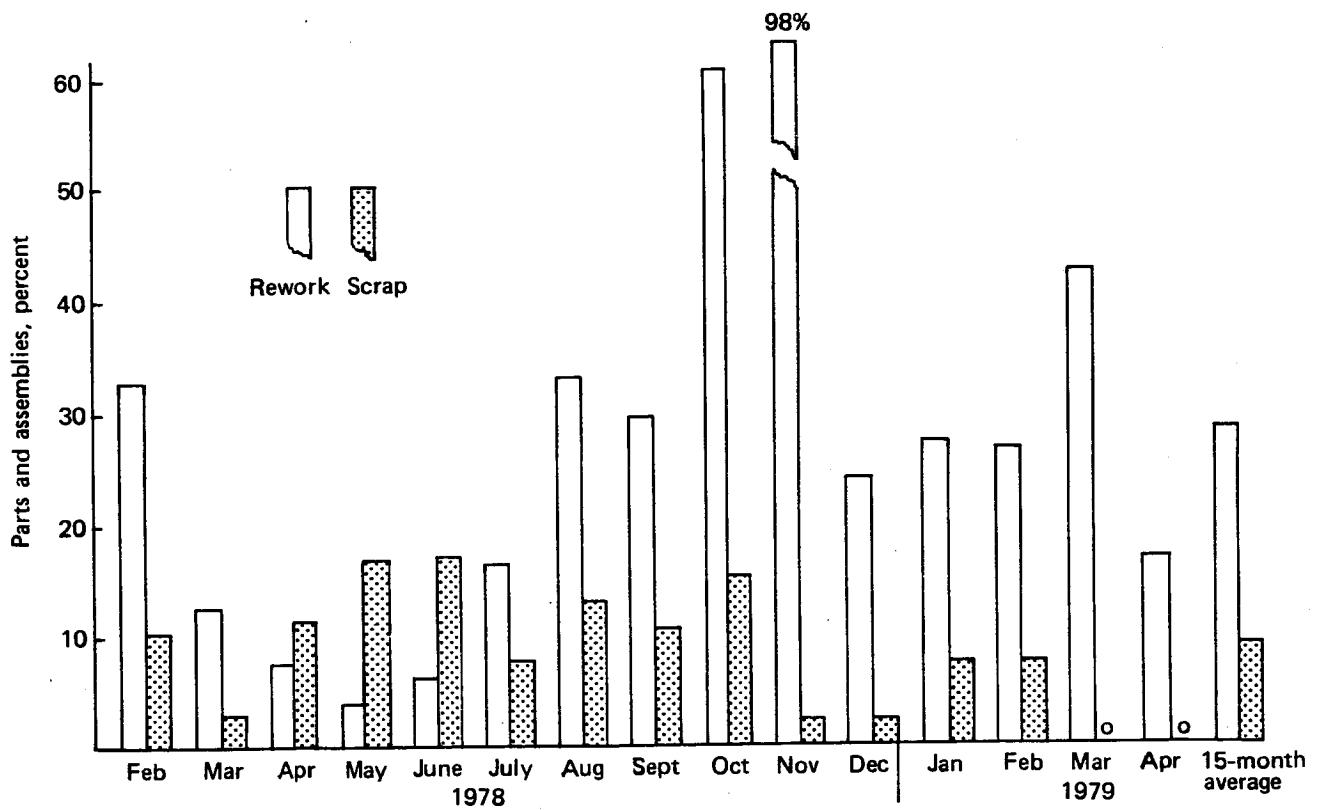
Figure 192. Rework and Scrap History

Production records for the program have been collated, analyzed, and the results tabulated. A total of 1828 details and assemblies, fabricated during February 1978 through April 1979, yield 937 discrepant conditions with some parts having more than one condition reported. These data are summarized in Table 15 and Figure 192.

Further analysis of the data showed that process failures comprised 25% of all rework and 58% of all scrap. Human errors, including operators and planning, contributed 75% of the rework and 42% of the scrap. This is comparable to metal structures early in the program.

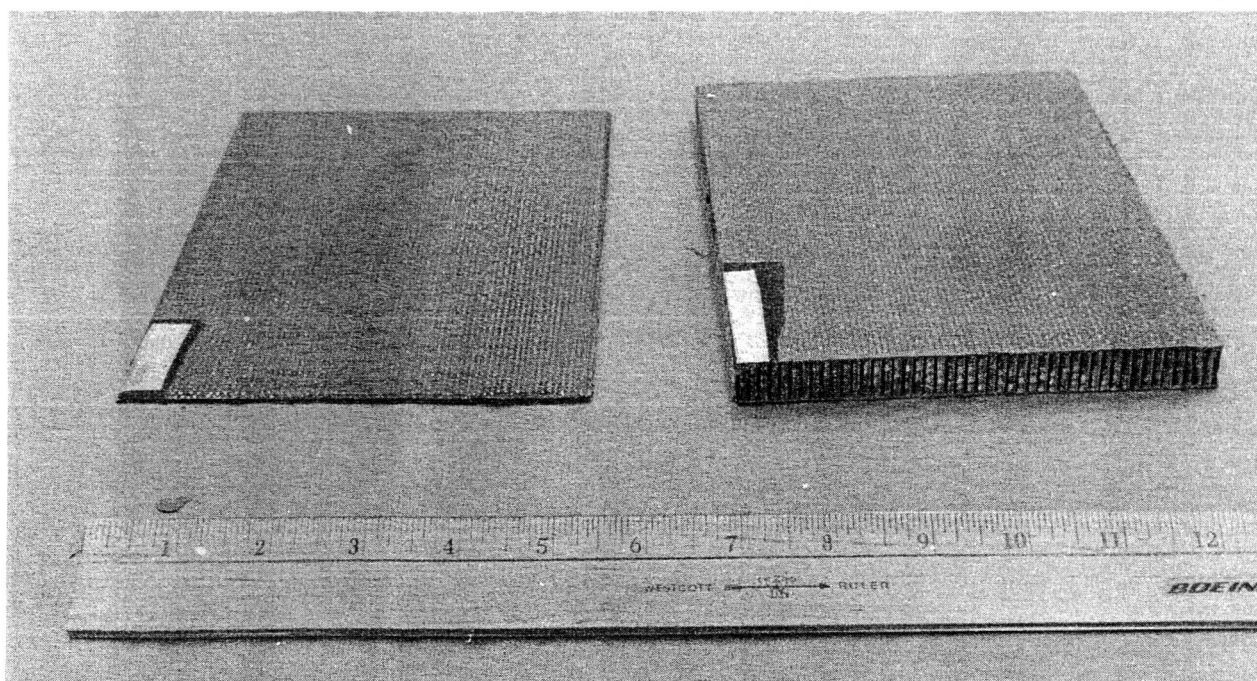
Figure 193. NDI Standards—Laminate and Honeycomb Panel

Laminate Standard—This standard was built with 0.64 x 0.64 cm (0.25 x 0.25 in) defects. It was required to qualify NDI techniques per Boeing Advanced Composites Process Specification. See Figures 193 and 194.

Honeycomb Standard—This standard, built with 0.64 x 0.64 cm (0.25 x 0.25 in) defects, was required to qualify NDI techniques. See Figures 193 and 195.

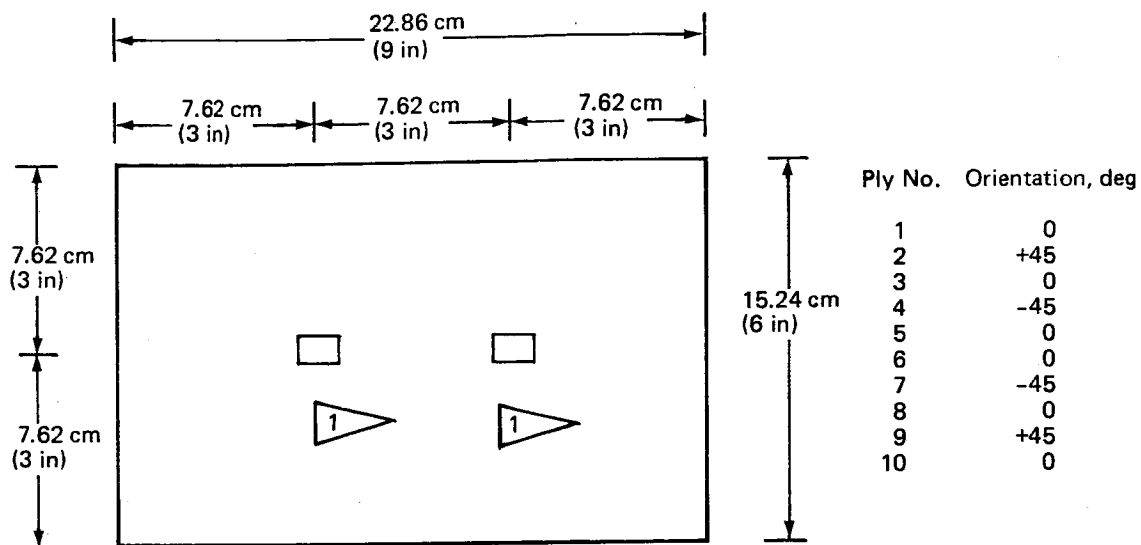
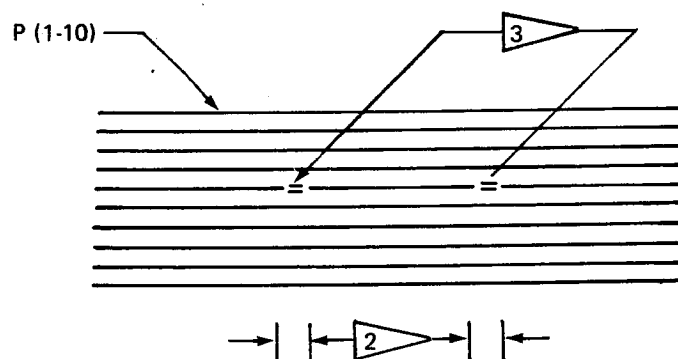
10 plies
BMS 8-212
Type II
Class 2
Style 3K-70-P

Fabricate per BAC 5562

Figure 194. NDI Reference Standard—Graphite-Epoxy Laminate

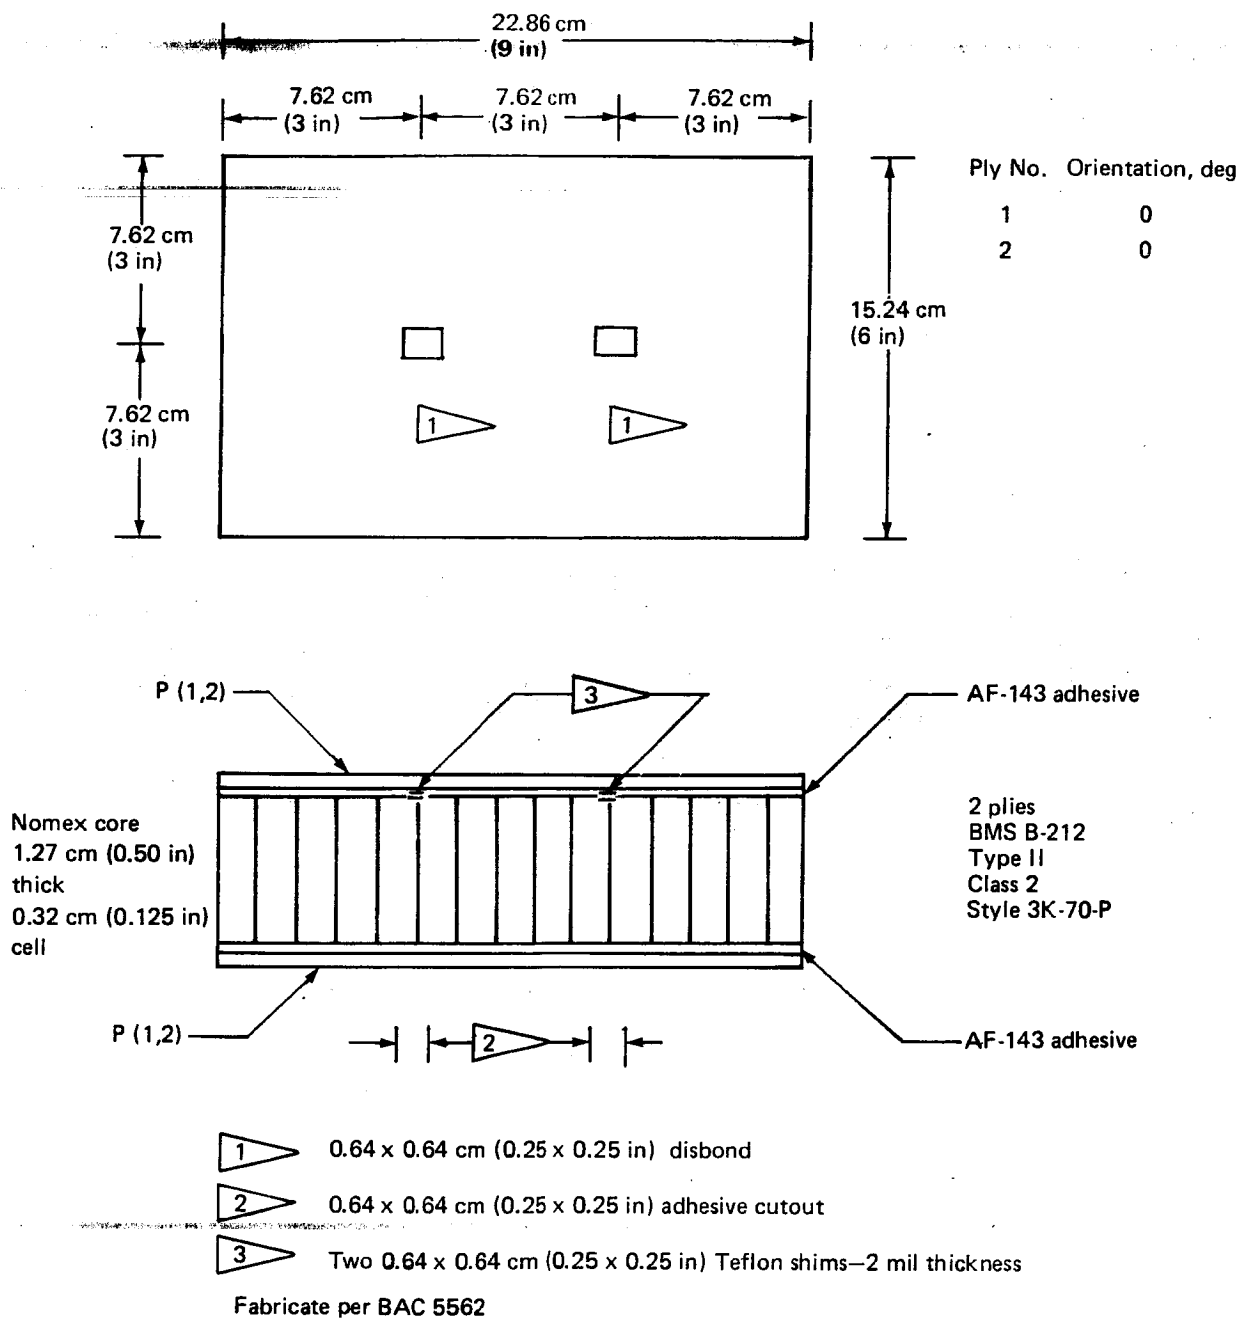
Figure 195. NDI Reference Standard—Graphite-Epoxy Honeycomb

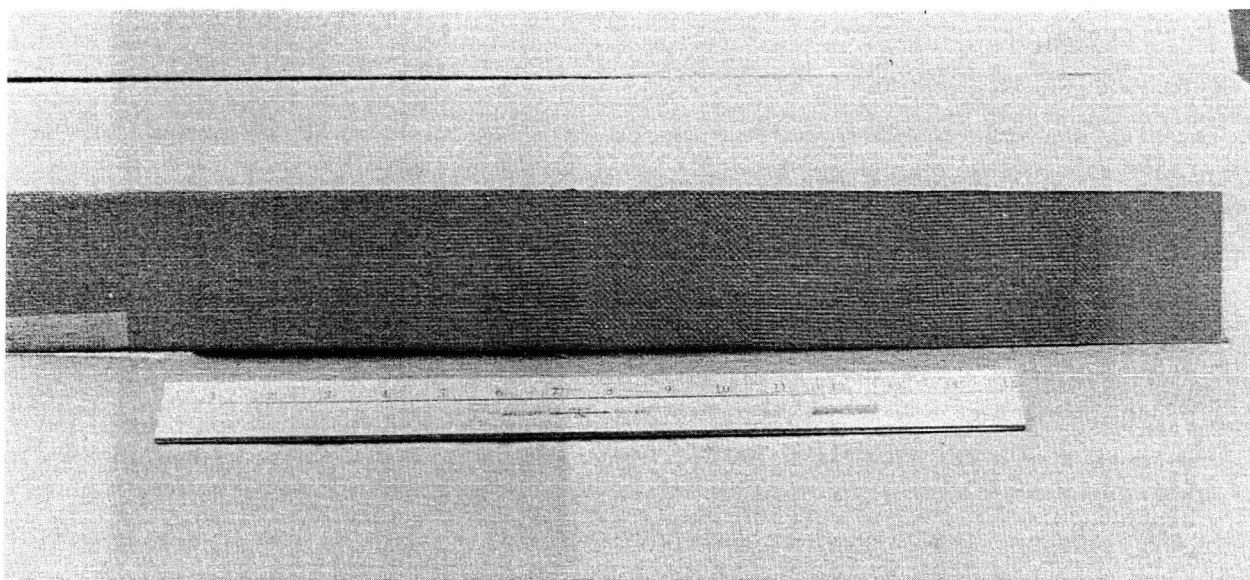
Figure 196. NDI Standard—Step Laminate

Laminate Step Standard—This standard consists of eight laminate steps with 0.64 x 0.64 cm (0.25 x 0.25 in) and 1.27 x 1.27 cm (0.5 x 0.5 in) defects in each step. The thicknesses of steps are 2P, 4P, 6P, 8P, 10P, 12P, 14P, and 15P. See Figures 196 and 197.

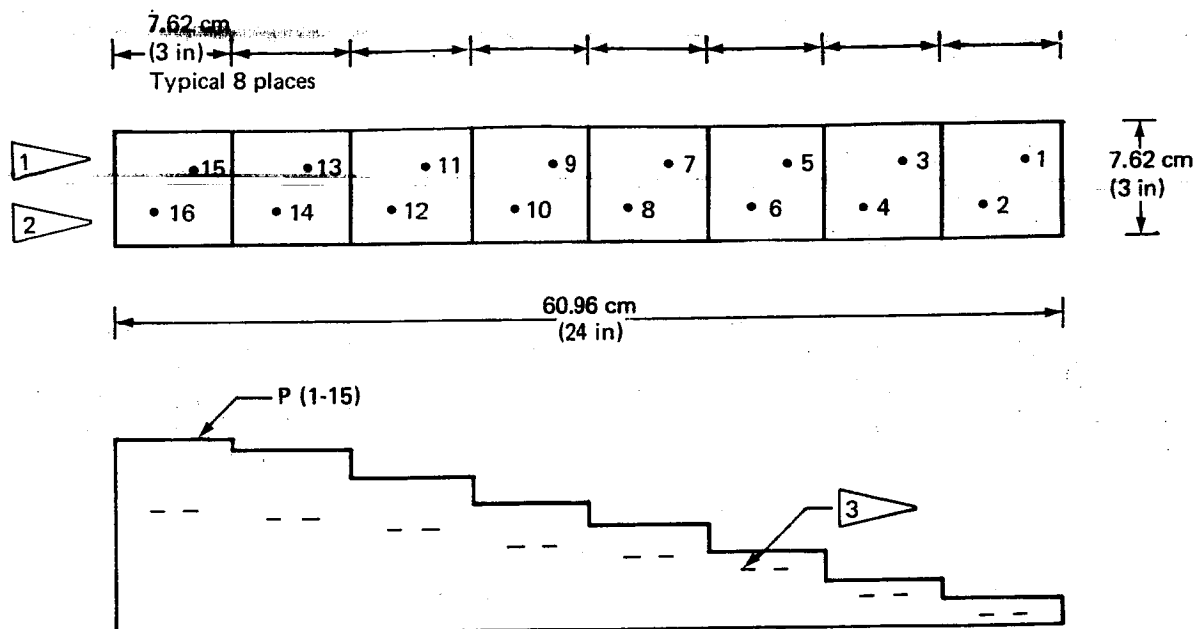
Defect No. 1 and 2 between P1 and P2
 Defect No. 3 and 4 between P3 and P4
 Defect No. 5 and 6 between P4 and P5
 Defect No. 7 and 8 between P5 and P6
 Defect No. 9 and 10 between P6 and P7
 Defect No. 11 and 12 between P7 and P8
 Defect No. 13 and 14 between P8 and P9
 Defect No. 15 and 16 between P9 and P10

- 1 0.64 by 0.64 cm (0.25 by 0.25 in) defect
 2 1.27 by 1.27 cm (0.5 by 0.5 in) defect
 3 Two 0.005 cm (0.002 in) Teflon shims of specified defect size

Ply No.	Orientation, deg	Ply No.	Orientation, deg
1	0	8	+45
2	+45	9	0
3	90	10	90
4	0	11	-45
5	-45	12	0
6	90	13	90
7	0	14	+45
		15	0

Figure 197. Laminate Step Standard
